Lot 12 Mangrove Restoration Progress Report**Sept. 2, 2011 Report****OGC Case No.: 08-1930****8/22/11**

Lot 12 Mangrove Restoration Progress Report

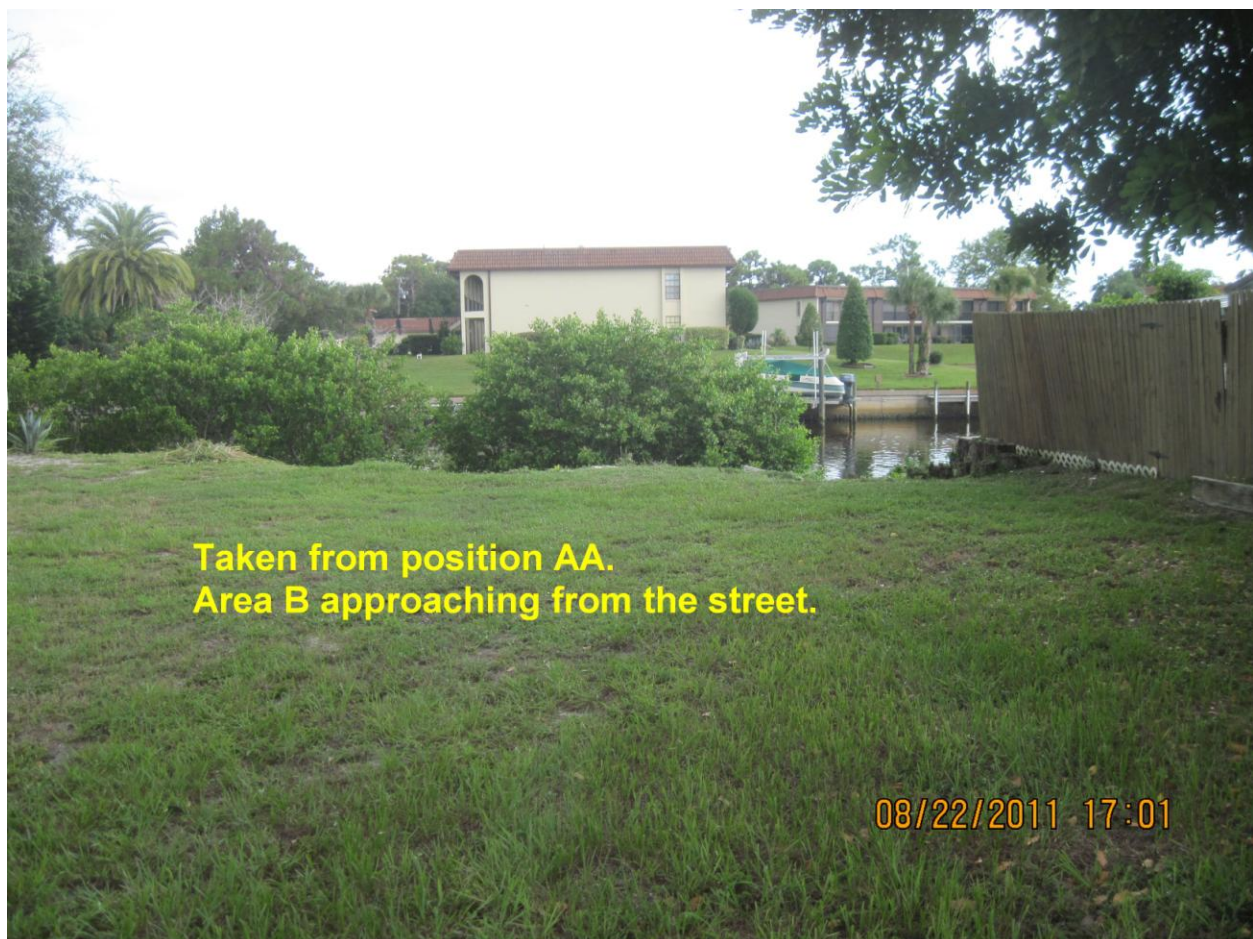
This was taken at a location half way between the carrotwood tree adjacent to the wood fence at 1309 Forked Creek Drive and the utility post 48 ft. out from the fence (location AA on the sketch). It shows the street view of the area where 15 large Australian pines had dominated Area B before being removed.

Area B: The large Australian pines were also removed earlier using trucks, rigging lines, chippers, power tools, and hand tools. The stumps have been drilled and stump killer inserted in the holes. We continue to spray shoots and seedlings with a systemic brush killer.

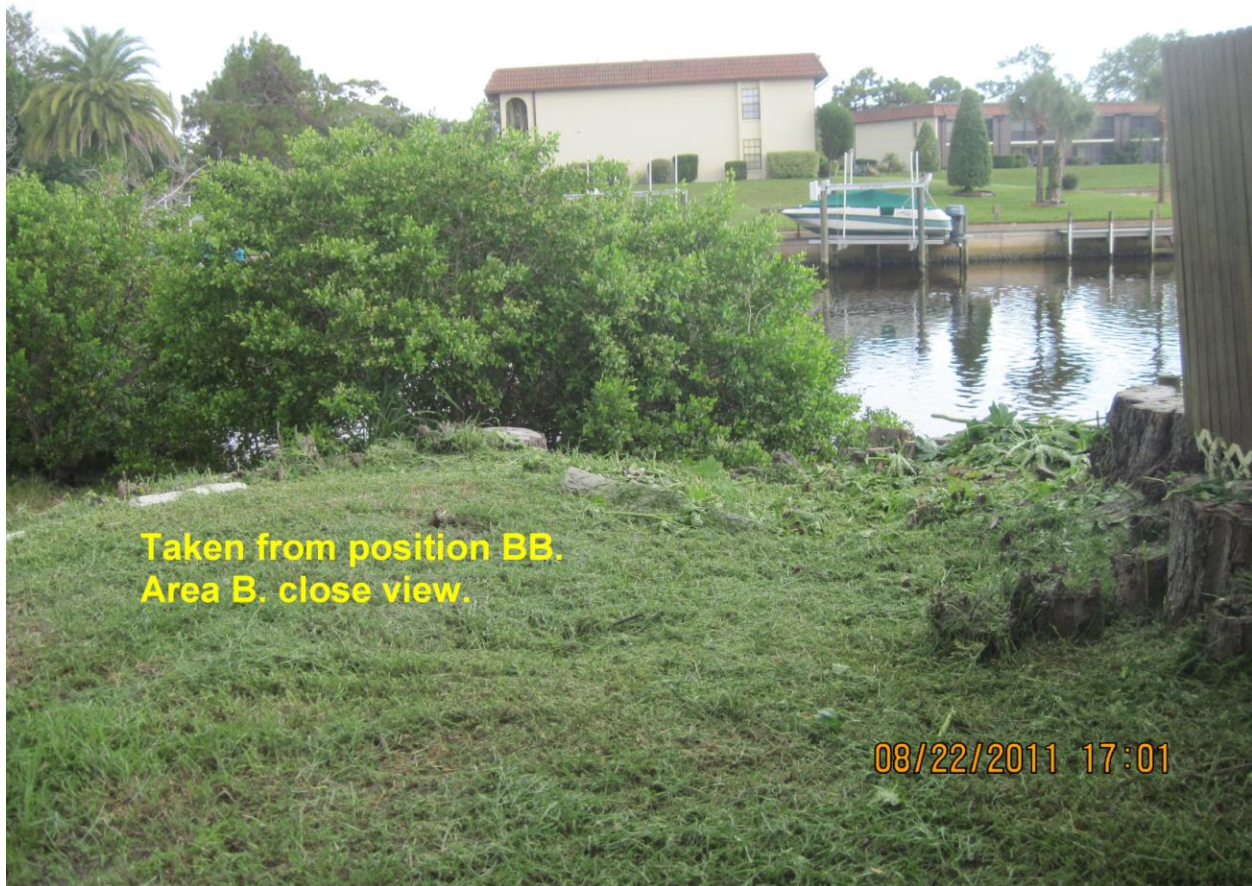
This was taken closer to the area where the large Australian pines have been removed. It was taken at position BB on the sketch, 16 ft. out from the gate jam post on the wood fence on the adjacent property.

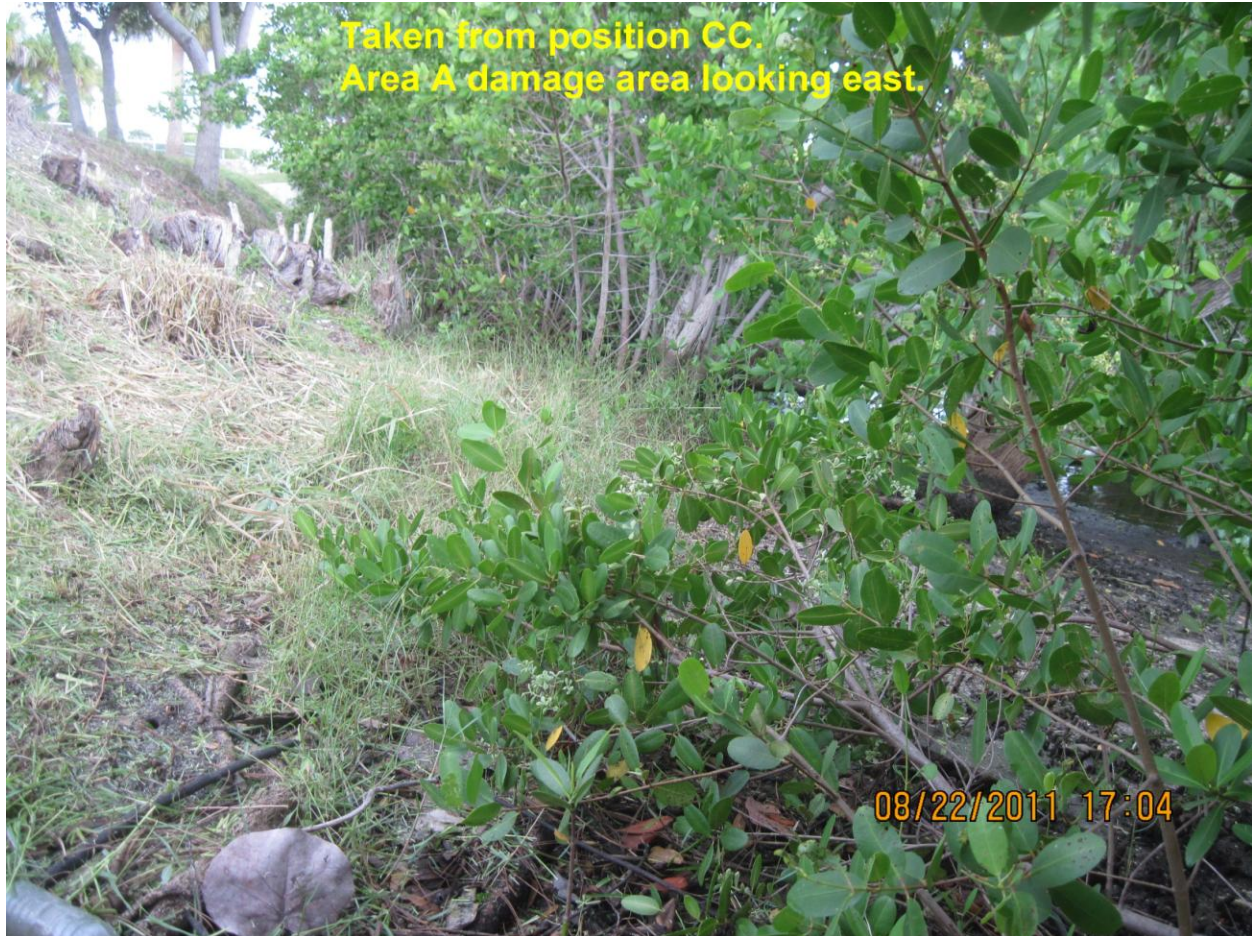
The height of the damaged mangroves ranges from about 5-23 inches. The percentage of cover is estimated to be less than 1 %. Restoration has suffered a setback as because of the frost damage due to the freezing temperatures in Dec. 2010 and again in Jan. 2011. Native grasses are growing into the mangrove restoration area that may also affect development of the young mangroves. The adjacent mature mangroves are expanding and appear to be shading the development area more which reduces the sunlight on the development area.

This was taken at position CC, standing just above the low tide water line, leaning against the south most Australian pine stump at the west end of Area B. It shows the damage in Area A.

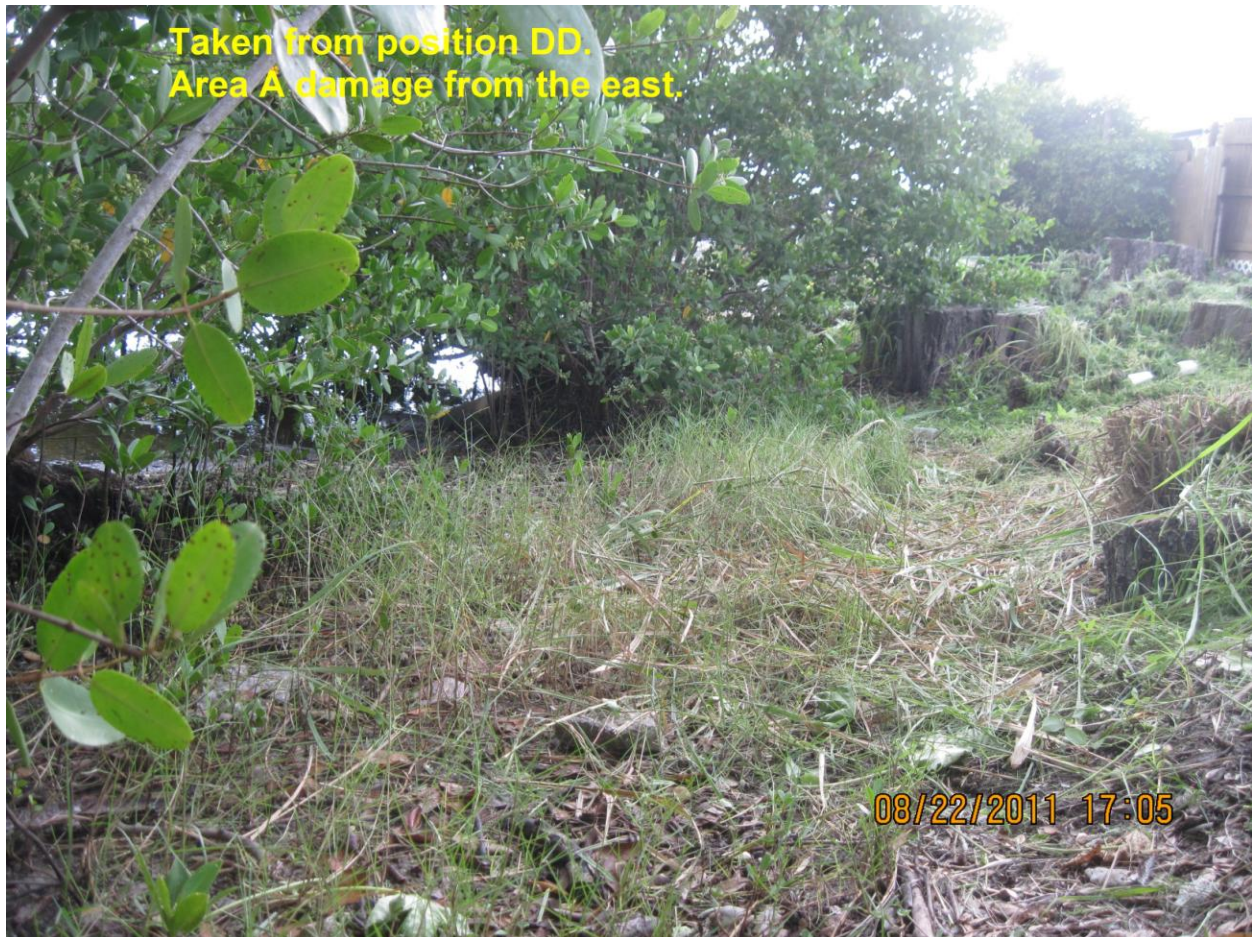
Same area of damaged mangroves as the previous photo but taken from the west at a position just below the oak tree on the bank at the east end of Area A, position DD on the sketch.
